WELL REHABILITATION AND PUMP INSTALLATION IN IDUNDILANGA DISPENSARY IN NJOMBE TANZANIA 1

ACTIVITY REPORT

December 2020

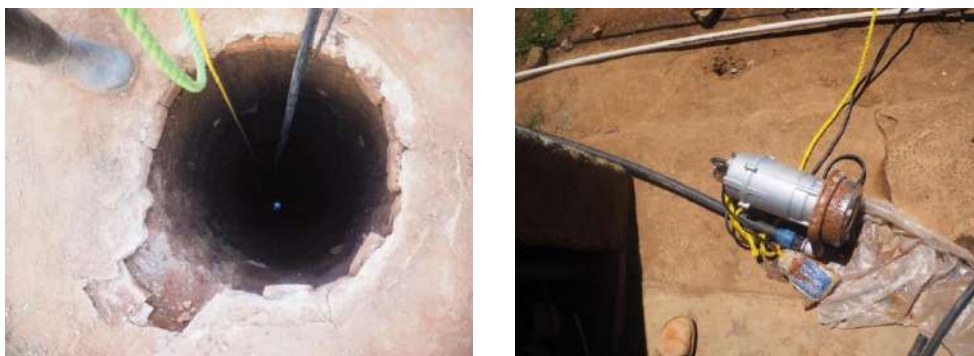
Figure 2: Manual digging inside the well to deepen the well 3 m (left) and the submersible pump used to pump the water out (right).

The existing hand-dug well was not providing enough water during the last months of the dry season (September - November); therefore, the depth of the well was manually increased by 3 m: from 15 m to 18 m. The well has a very fast recharge rate so a submersible pump had to be used to pump the water out while digging (Figure 2). After the increase of 3 m, the water recharge rate was measured (60 L/min) and it was considered to be enough for both the dispensary and community use by the technical team. Although the soil type in Njombe does not normally lead to the collapse of the wells, for safety reasons, the last 6 m of the well were lined with bricks (Figure 3).

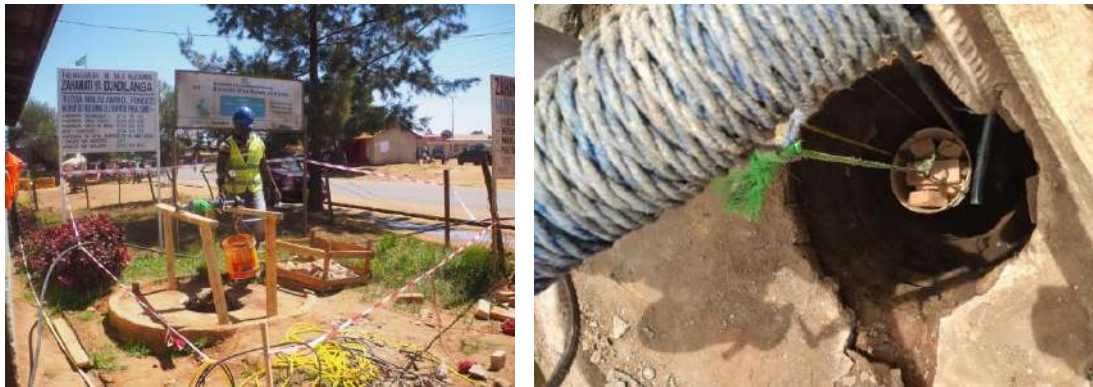
Figure 3: Lining of bricks inside the well to avoid collapsing of the soil.

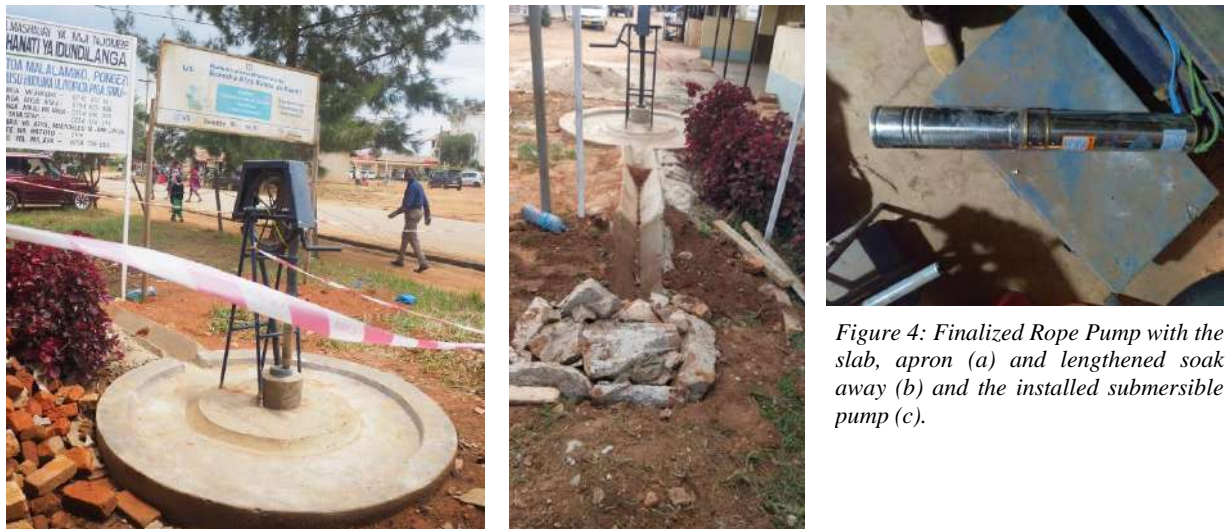
Figure 4: Finalized Rope Pump with the slab, apron (a) and lengthened soak away (b) and the installed submersible pump (c).

A submersible pump of 1 HP was installed in the well to pump water to the storage tank connected to the dispensary. The pump switch was placed inside the dispensary. The Rope Pump which was in the well before the start of the works was reinstalled but the rope with pistons was replaced with a new one. The rope pump was installed with a new concrete slab, the apron was maintained as before but the soak away was lengthen and some stones were added at the end to avoid stack water (Figure 4). Figure 5 shows the trenches where the connection pipes to the tank were set.

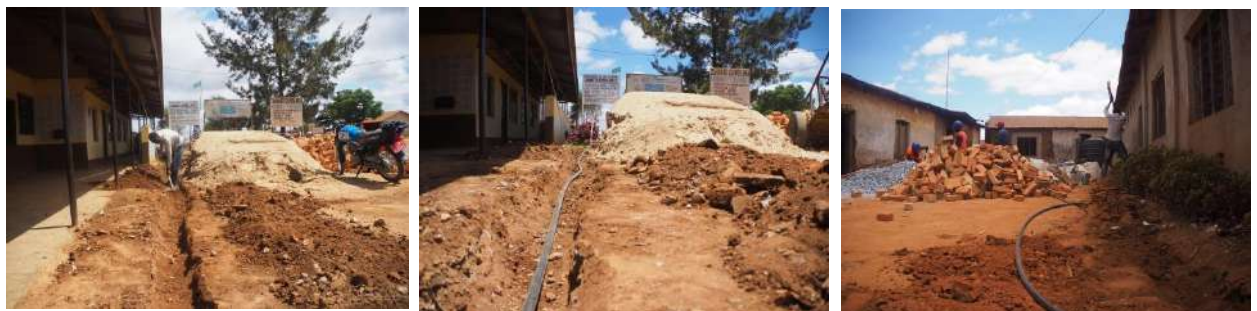
Figure 5: Digging the trenches and installing the connection pipes from the well to the storage tank.

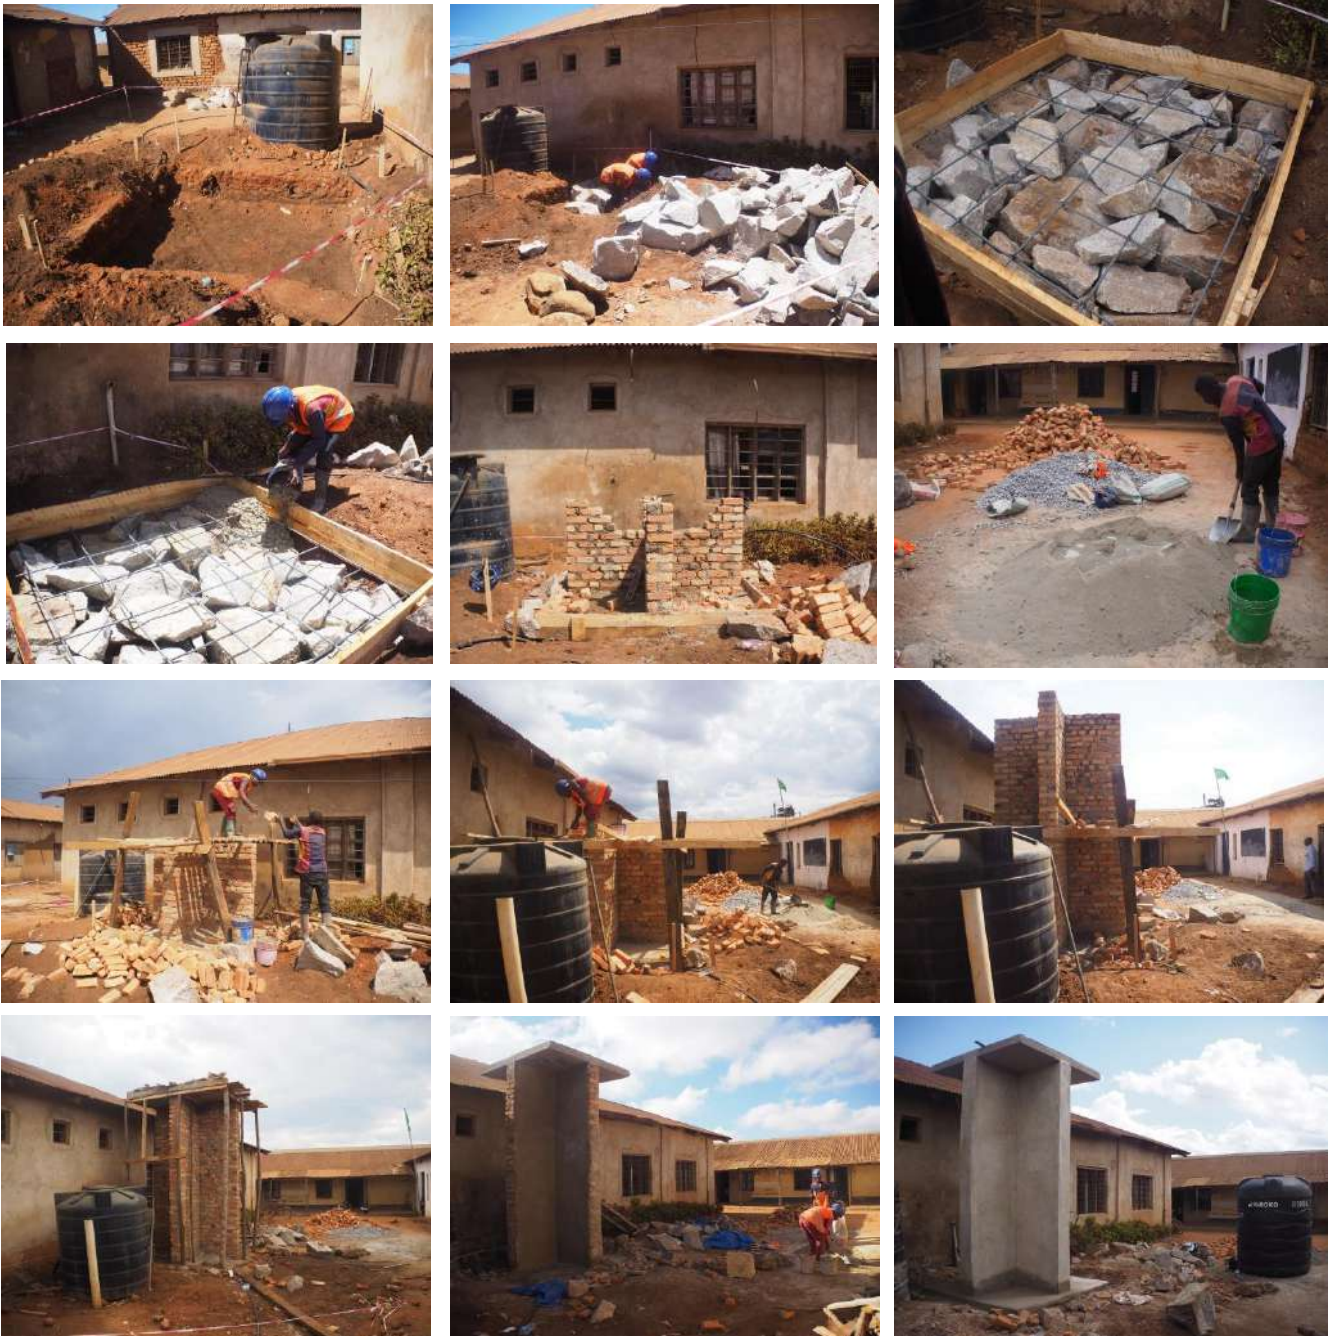
Figure 6: Different steps in the construction of the tank tower.

The water storage tank and the wooden platform present in the dispensary were in bad condition; therefore, a tower was built with bricks and cement and a new and bigger storage tank were provided: the tower can bear a 5,000 L tank and it is 3.5 m high to ensure that the water is supplied with enough pressure. Figure 6 shows the different steps of the tower construction.

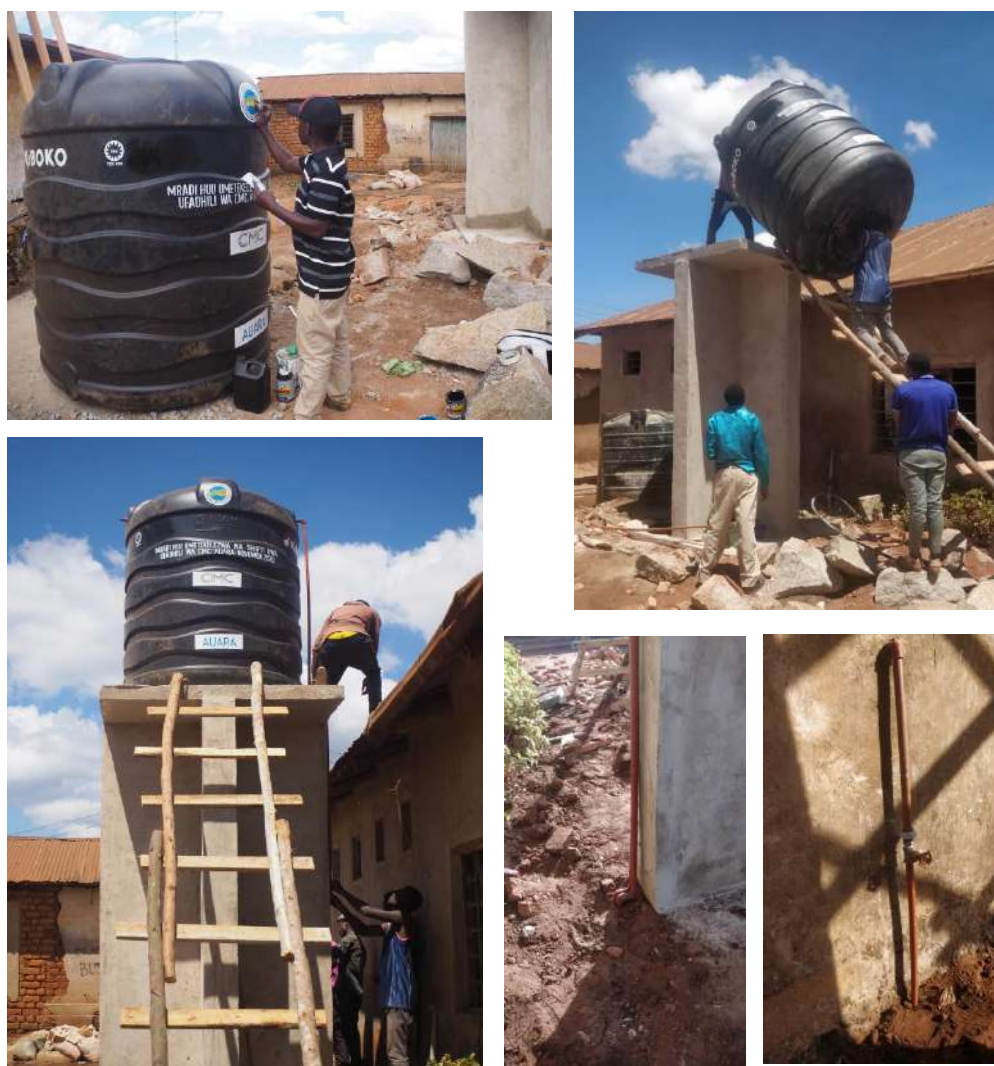
Figure 7: Painting the logos in the storage tank, lifting the tank to the tower and connecting the pipes to the inlet pipe of the dispensary.

The 2,000 L tank, which was not in a good condition –too old and dented – was substituted with a new PVC tank of 3,000 L. The logos of the back donor (CNC), promoter (AUARA) and implementer (SHIPO) of the project were painted in the tank together with a short explanation about the project. The tank was connected to the inlet pipe of the dispensary directly; no tap was placed outside in order to avoid that external people fetch water from the tank.

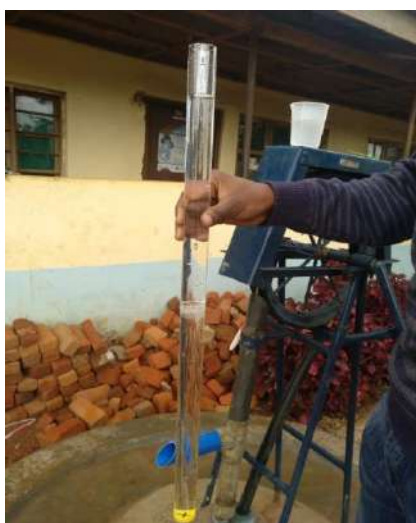
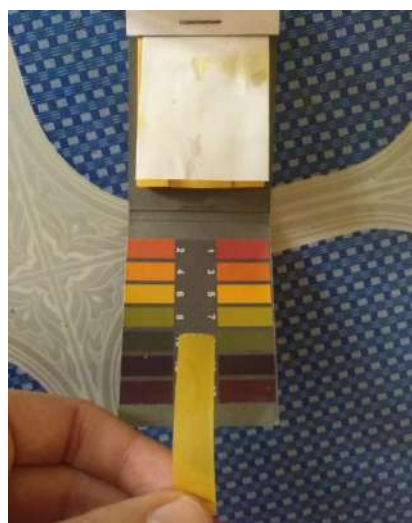
Figure 9: Turbidity test performed in the sample from the Rope Pump (left); pH strip showing the range for the water collected in the dispensary.

The **quality** was tested for both the water from the rope pump and the water inside the dispensary coming from the storage tank. 3 parameters were measured: pH, turbidity and faecal coliforms. pH test strips were used to determine the pH of the water and in both cases a pH in the range of 6-7 was measured. A turbidity tube test showed that in both cases the sample had below 10 NTU. Faecal coliforms were determined through the membrane filtration method in FC agar medium and no colonies were observed in the 3 samples tested for each of the two cases. The water quality results show that the water is appropriate for human consumption for the parameters tested (Table 1). Figures 9 and 10 show different steps of the water quality analysis.

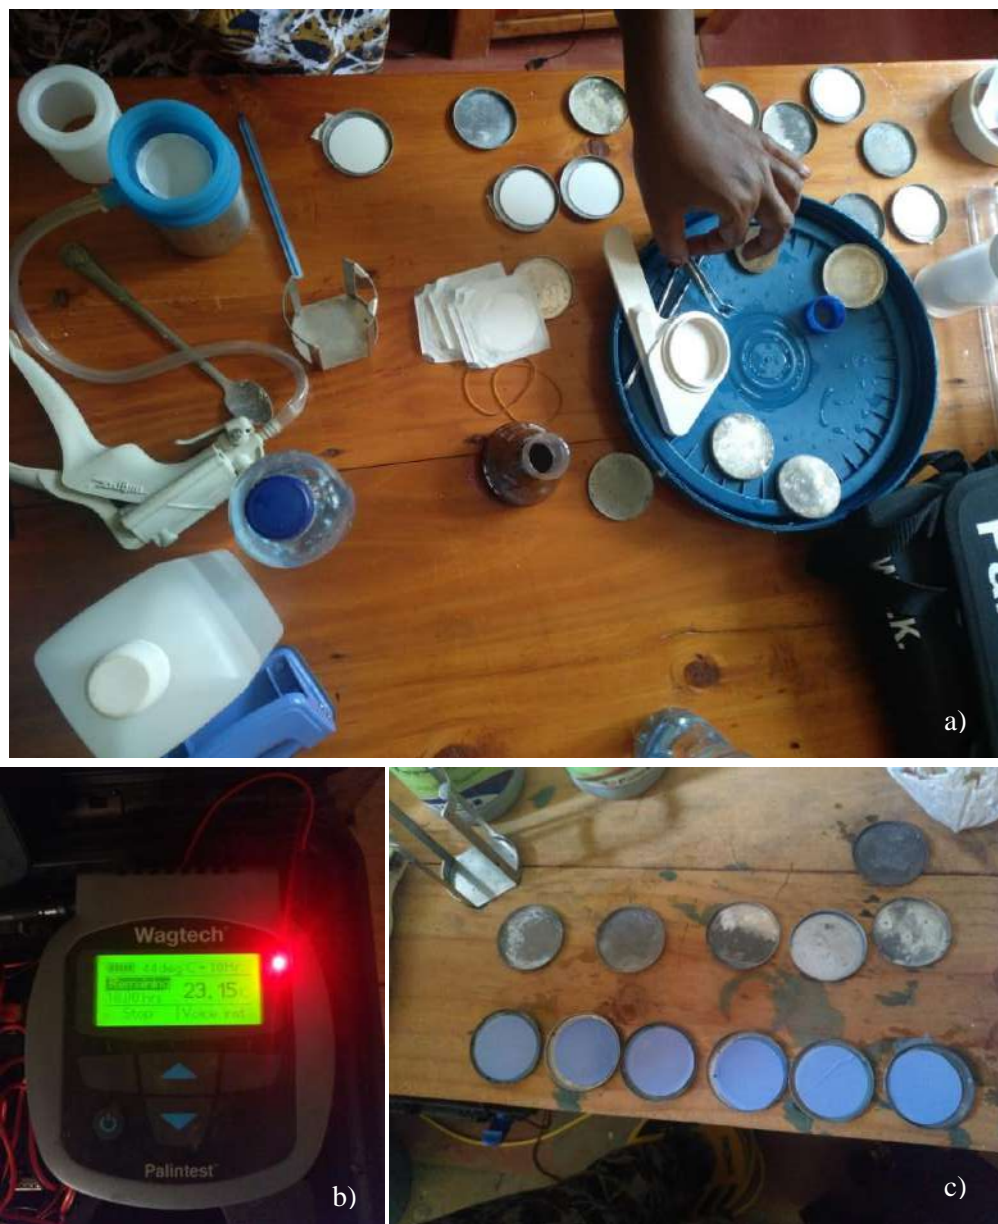
Figure 10: Faecal coliform determination: filtration equipment (a), setting the incubator (b) and end result with no observed colonies in the plates (c).

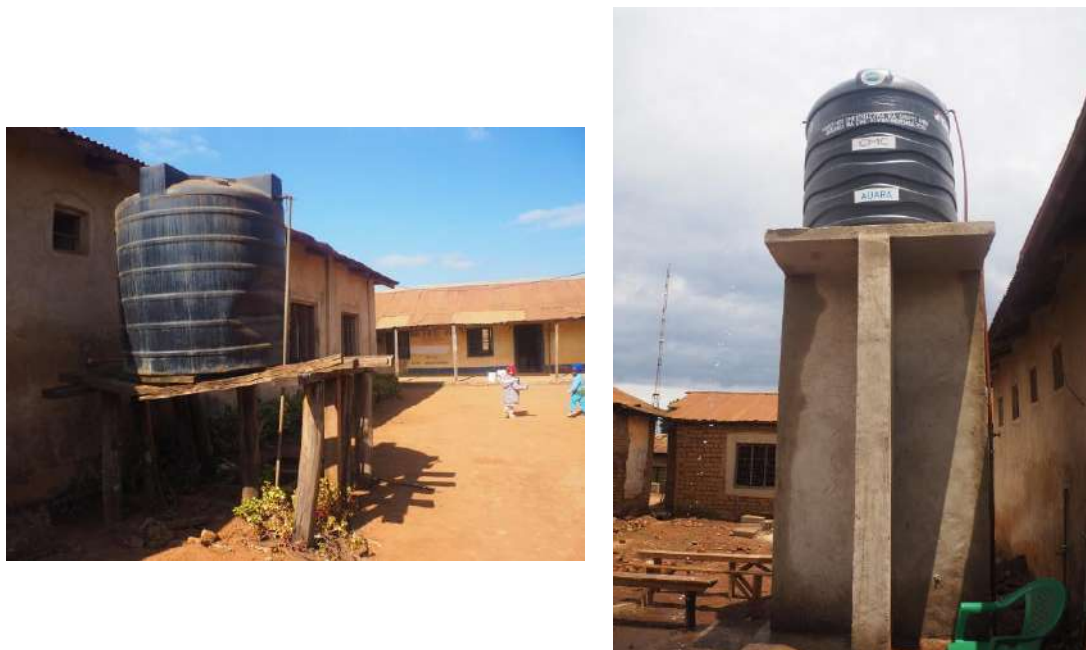
Figure 11: Storage tank before and after the project implementation.

The project has been successfully completed and the Idundilanga dispensary patients (around 1,000 people per month), the 7 health workers and the community members who live and work around the dispensary are already benefitting from the project. The well supplies enough water to meet the current demand at the end of the dry season (the worst-case scenario). The dispensary gets water directly at the premises with no need of hand-pumping and with enough pressure. Figure 11 shows the storage tank and tower before and after the project.

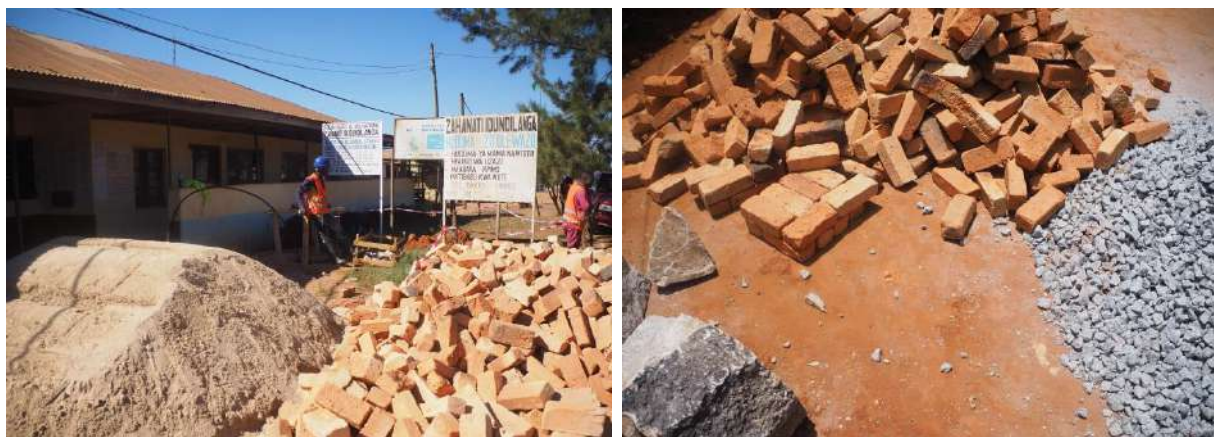
Since the WASH needs assessment performed in July, a big interest in the project from the LGA-s and the dispensary workers was observed. The community contribution in terms of local materials (Figure 12) to the project was a bit higher than initially expected but the community representatives agreed to increase their contribution after the evaluation by the technician.

Figure 12: Materials contributed by the community: bricks, sand and aggregate

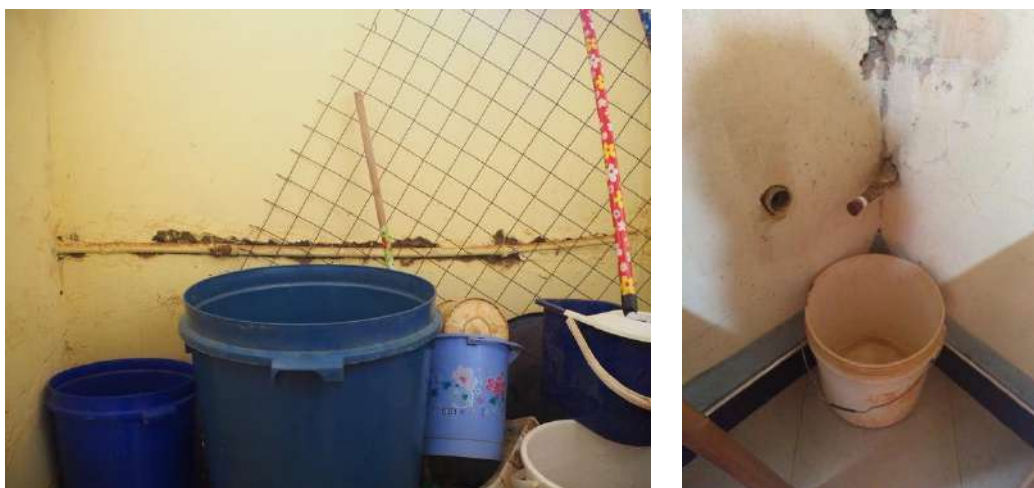
Thanks to the project, now Idundilanga dispensary gets water supplied into their premises. However, the water distribution system inside the dispensary is outdated and needs renovation, as it can be seen in Figure 13. The system should be renovated soon so that the dispensary can fully benefit from the project.

Figure 13: Water distribution system inside the dispensary: a pipe in the wash room (left) and an outlet in the laboratory (right).

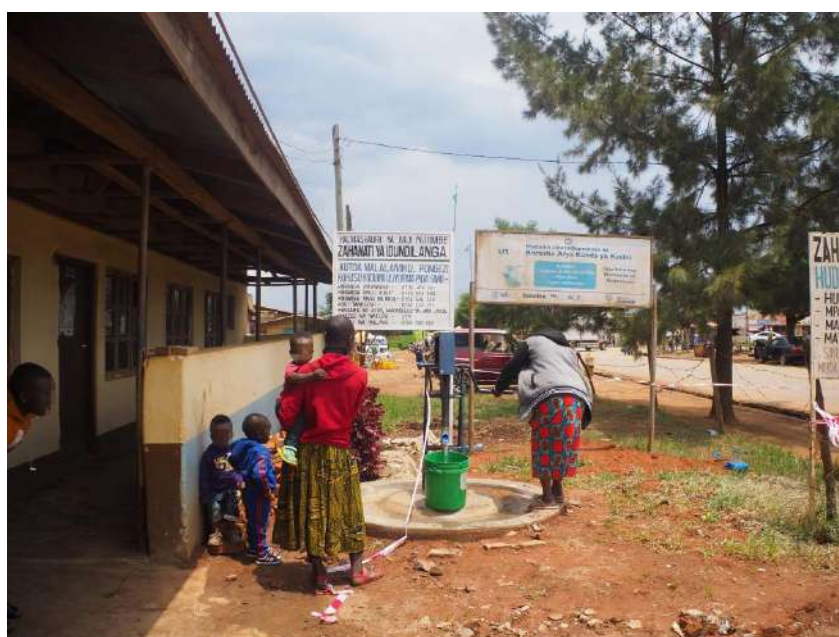
A couple members of the community who are daily users of the well were trained in simple steps for the maintenance of the rope pump (applying oil, properly placing the rope, etc.). As it is always done by all the groups of artisans trained by SHIPO SMART Centre, the contact phone number of the group was left in a small sheet attached to the pump in case any major problem arises in the future. Since the completion of the project, the community has locked the rope pump so whoever needs to fetch water can ask for the key in a shop next to the dispensary. This will help to keep record and control the use of the rope pump. In this way, it will be easier to get the contribution from users for the maintenance of the rope pump. Figure 14 shows several members of the community fetching water from the rope pump.

Figure 14: Some members of Idundilanga community fetch water from the rope pump.
